Maria Bostenaru Dan

Vernacular and Modernist Housing in Germany and Romania

An Analysis of Vulnerability to Earthquakes

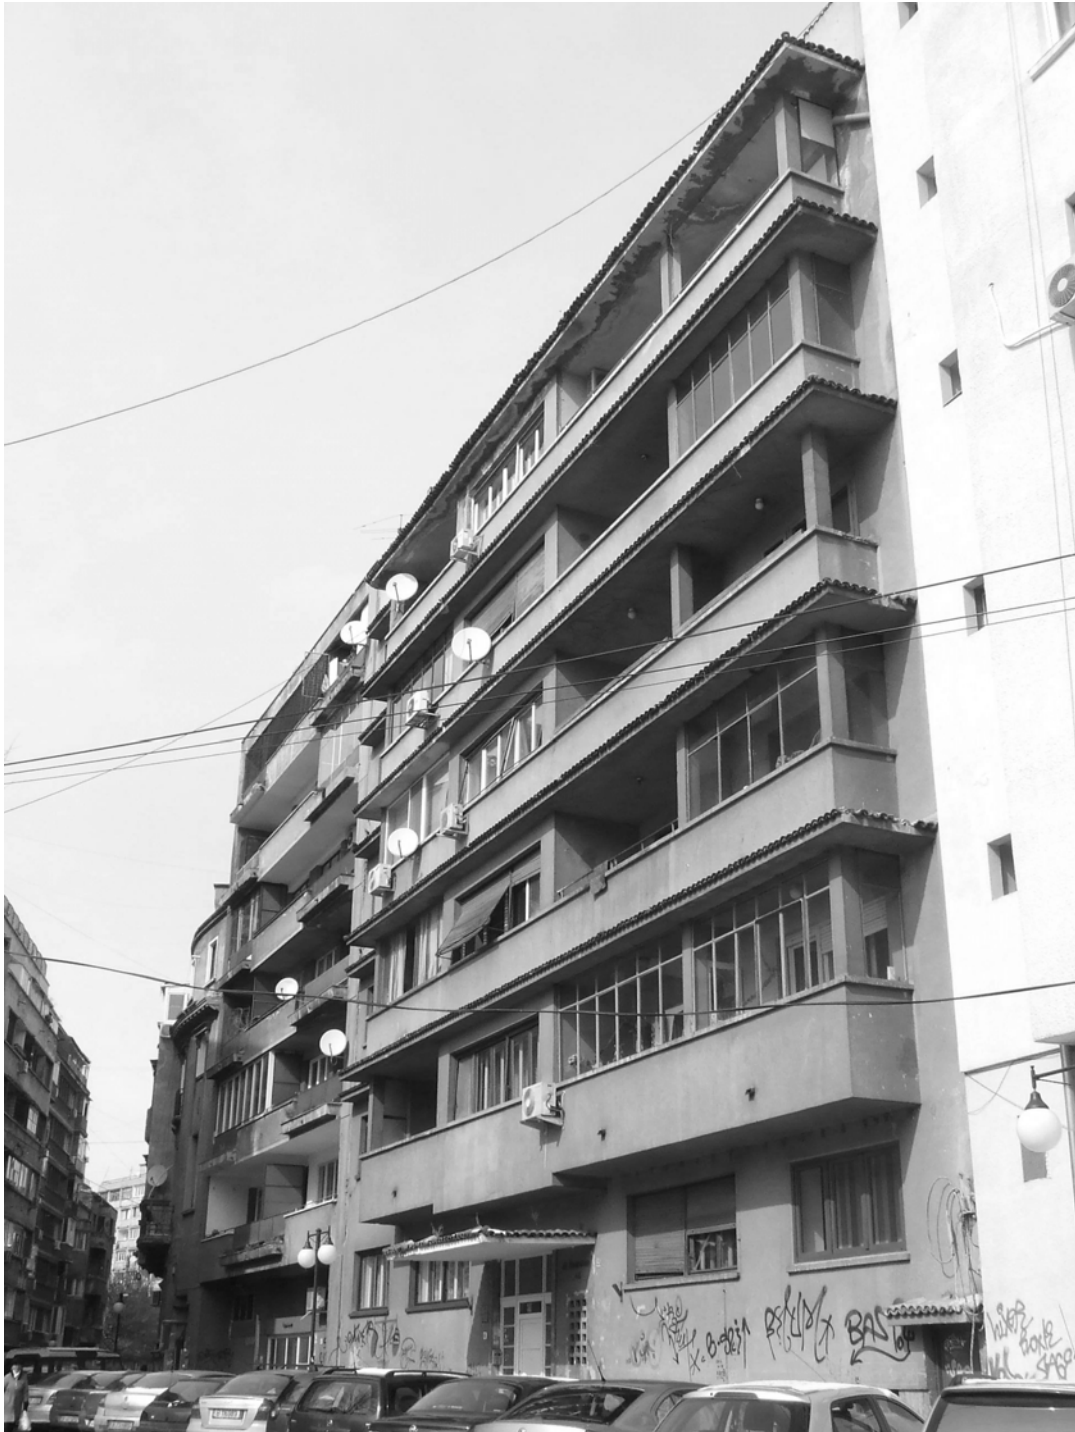
Figure 1-1: Block of flats on Brezoianu street (1946-48), architect Henrietta Delavrancea-Gibory, combining traditional and modern elements. Photo by Maria Bostenaru, 2010.

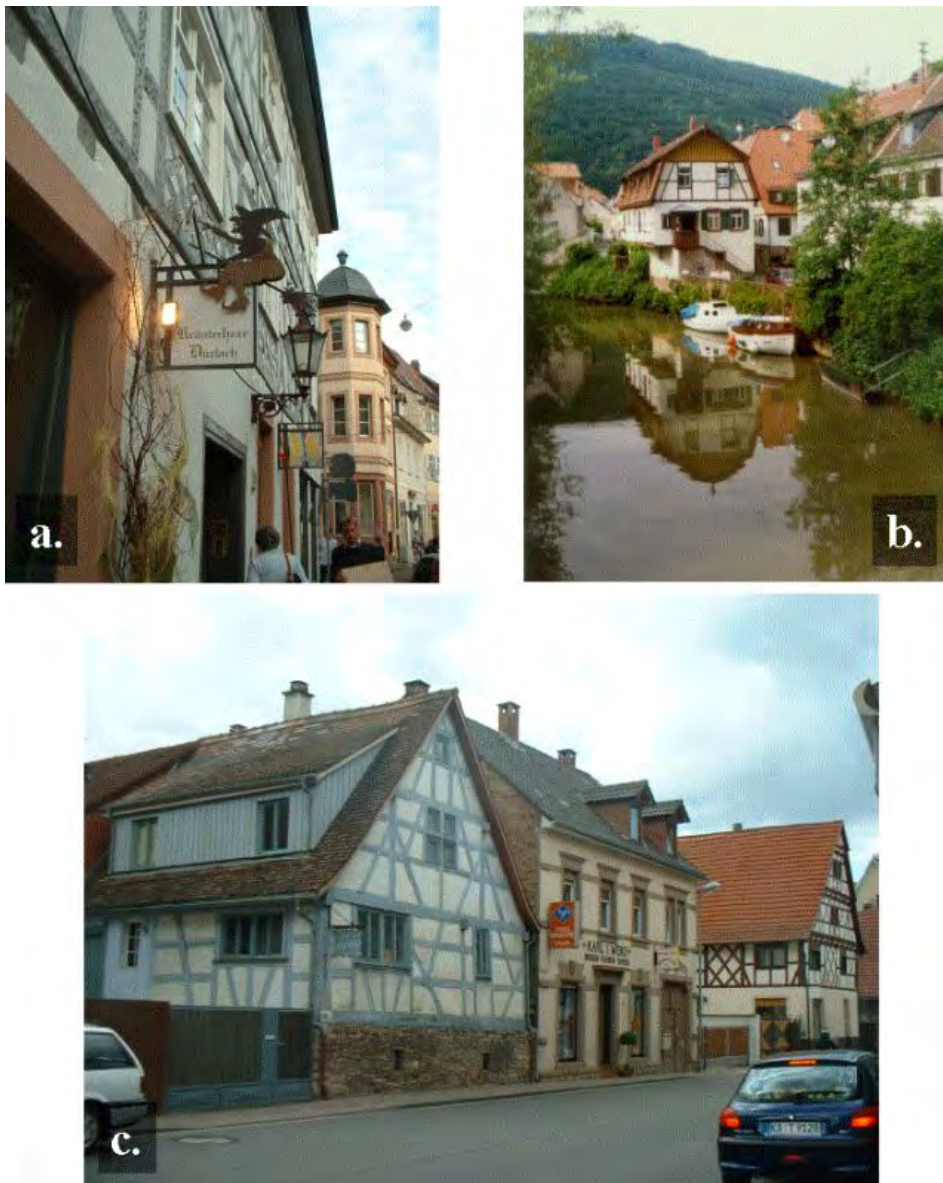
Figure 2-1: "Fachwerk" houses in Germany: a. in an urban area; b. and c. in rural areas; a. and c. southern Germany; b. central Germany. a. and c. photos by Michael Kauffmann, 2004, b. by Maria Bostenaru, 1997.

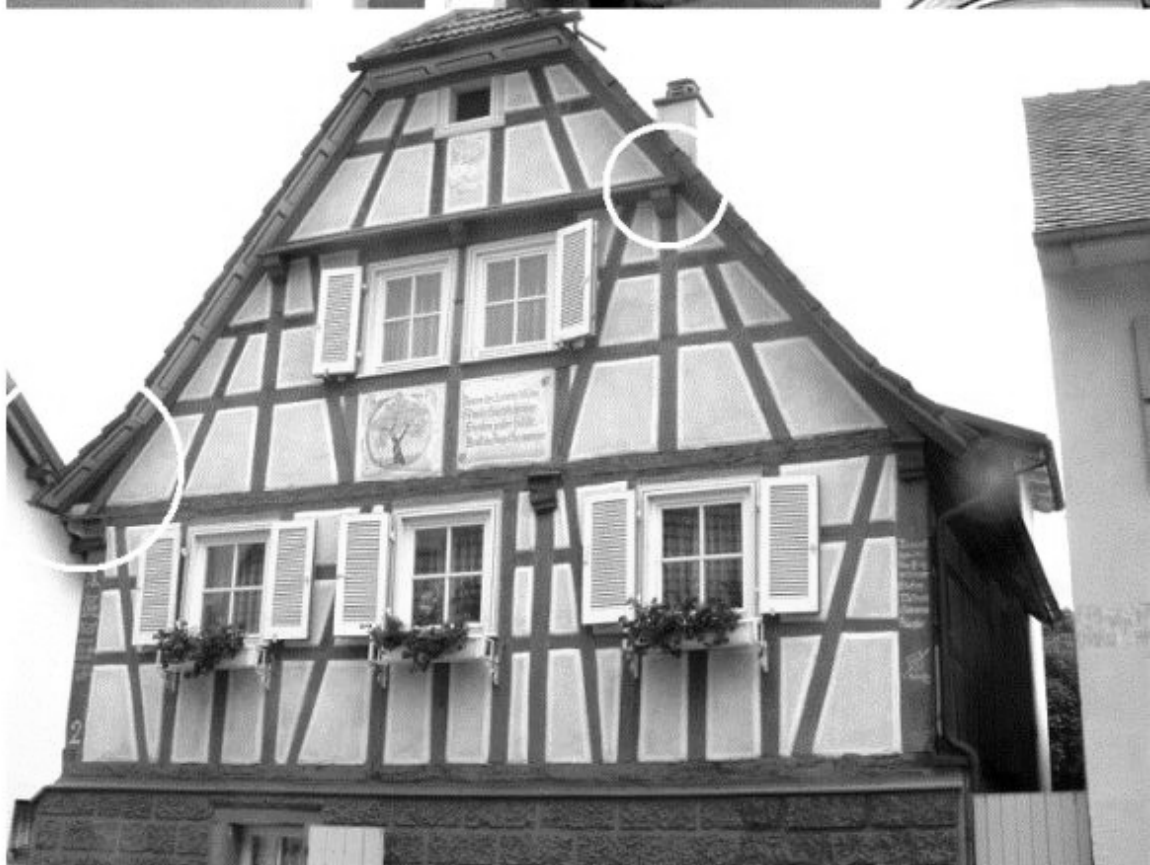
Figure 2-18: Connection between horizontal and vertical load bearing elements: side wall (top) and typical gable solution (bottom). Photos by Michael Kauffmann, 2004.

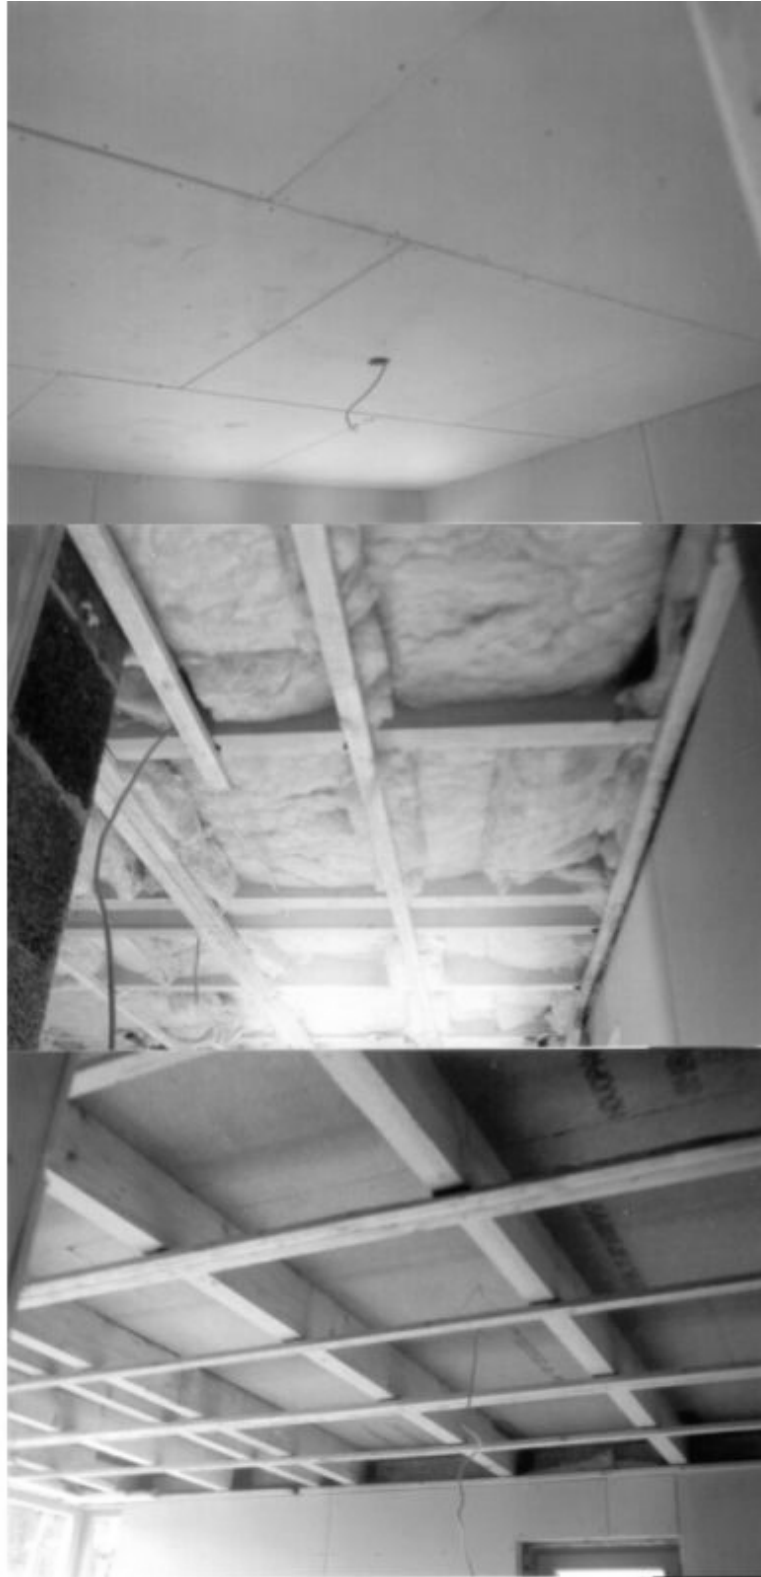
Figure 2-21: Construction details of floors (new building): from bottom to top different steps in finishing. Photos by Maria Bostenaru, 1998.

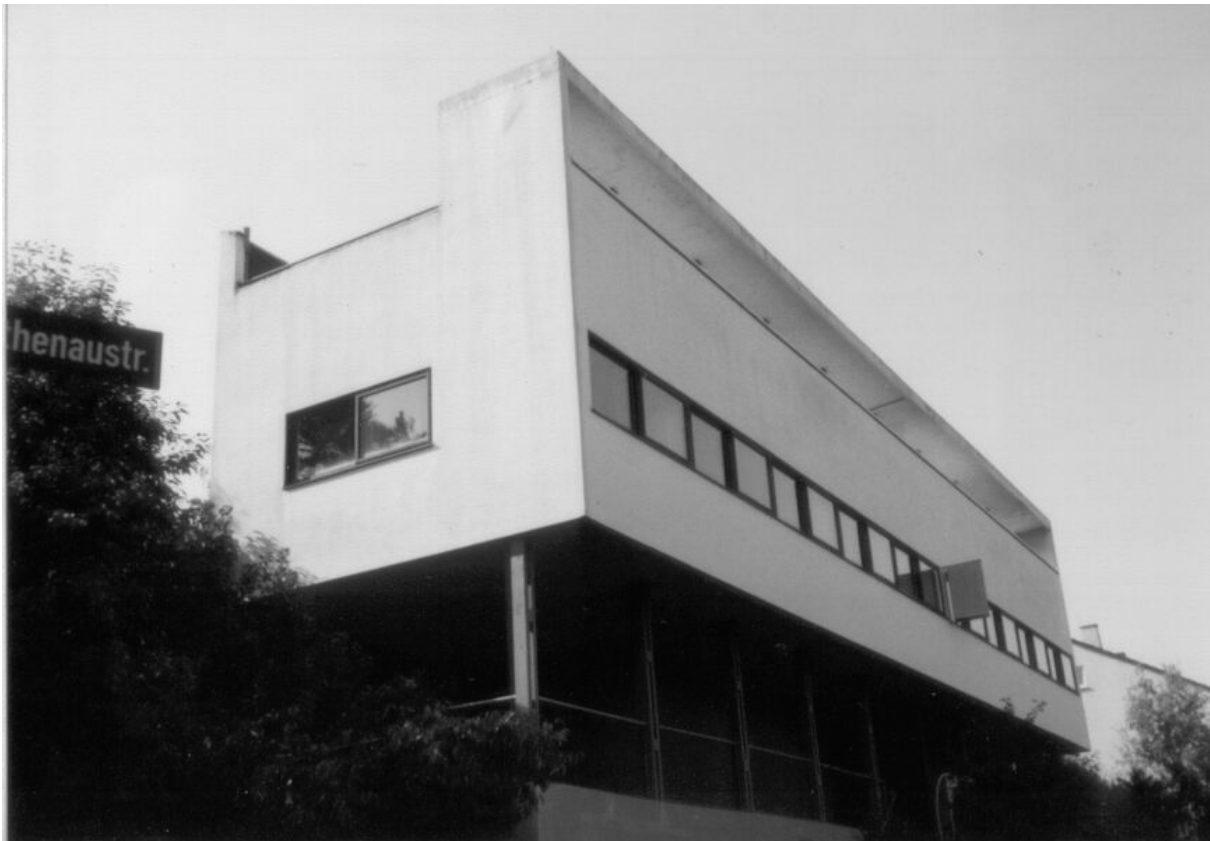
Figure 3-7: A renowned building of this type: Le Corbusier's building in Stuttgart Weissenhof (1927) - a mix of reinforced concrete and metal structure: free standing columns out of metal. Photo: M. Bostenaru, 2002

Buildings of this construction type can be found in Karlsruhe (1929 Dammerstock: Fig. 3-3, 3-4), Frankfurt, Berlin, Stuttgart (1927 Weissenhof: Fig. 3-7), Kassel (1929 Rothenberg), Celle (1930 Blumlagerfeld) and others. Some 300,000 residential units (see "Weisse Vernunft", 1999) were built. This type of housing construction is commonly found in sub-urban areas. This construction type has been in practice for less than 100 years. Currently, this type of construction is not being built. This construction type had been practiced up to the world economy crisis.

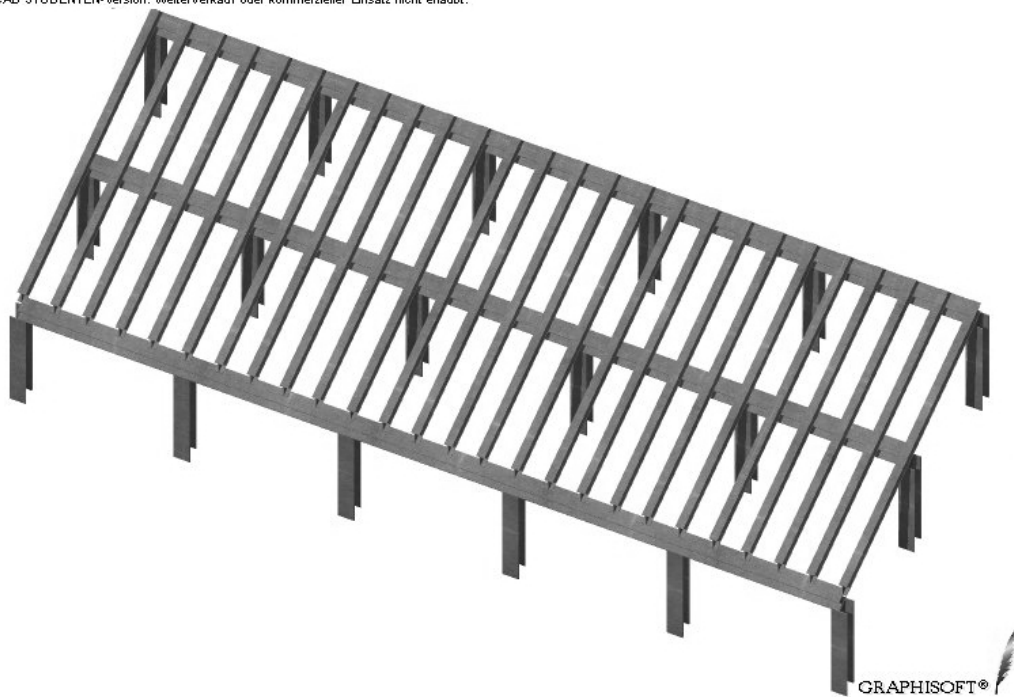
Figure 3-13: Axonometric view of key load bearing elements in variant 1

The vertical load-resisting system is others (described below). Iron schelet (fig. 3-11 – 3-13) with infill walls of half clay or "Schwemmstein" bricks support the gravity loads. The connections are made with screws over corner elements in the upper floors and in the basements and at column base with nits (fig. 3-16). The statics were computed for a 10cm thick brick-iron floor. Iron/steel frames are one storey high and later infilled with masonry (Stuttgart, Karlsruhe). In Celle many joists are missing and vertical load bearing elements are spaced 85cm. Gravitational loads are transmitted directly to the foundation. Here the skelet serves as "Fachwerk" up to the cornice.

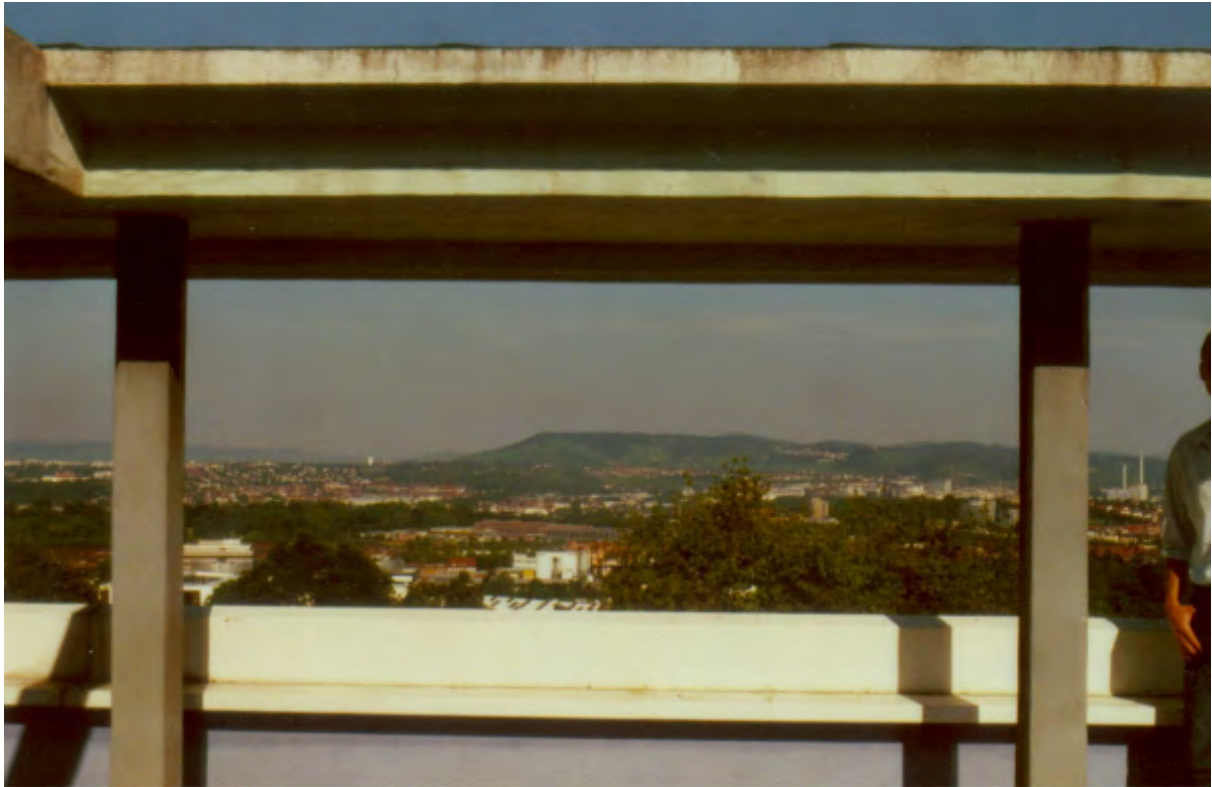
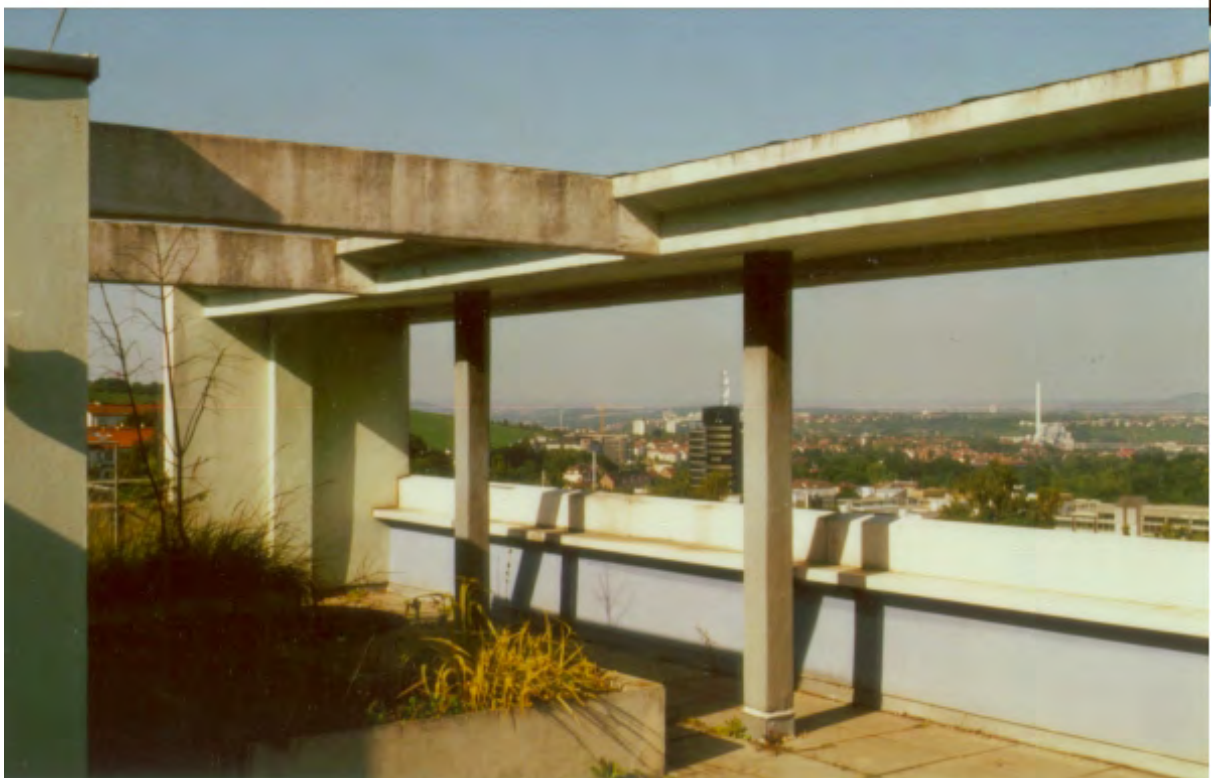
Figure 3-18: Details showing the way horizontal and vertical (iron)reinforced concrete and vertical metal elements are combined in Le Corbusier's building in Stuttgart Weissenhof. Photos by Maria Bostenaru, 2002.

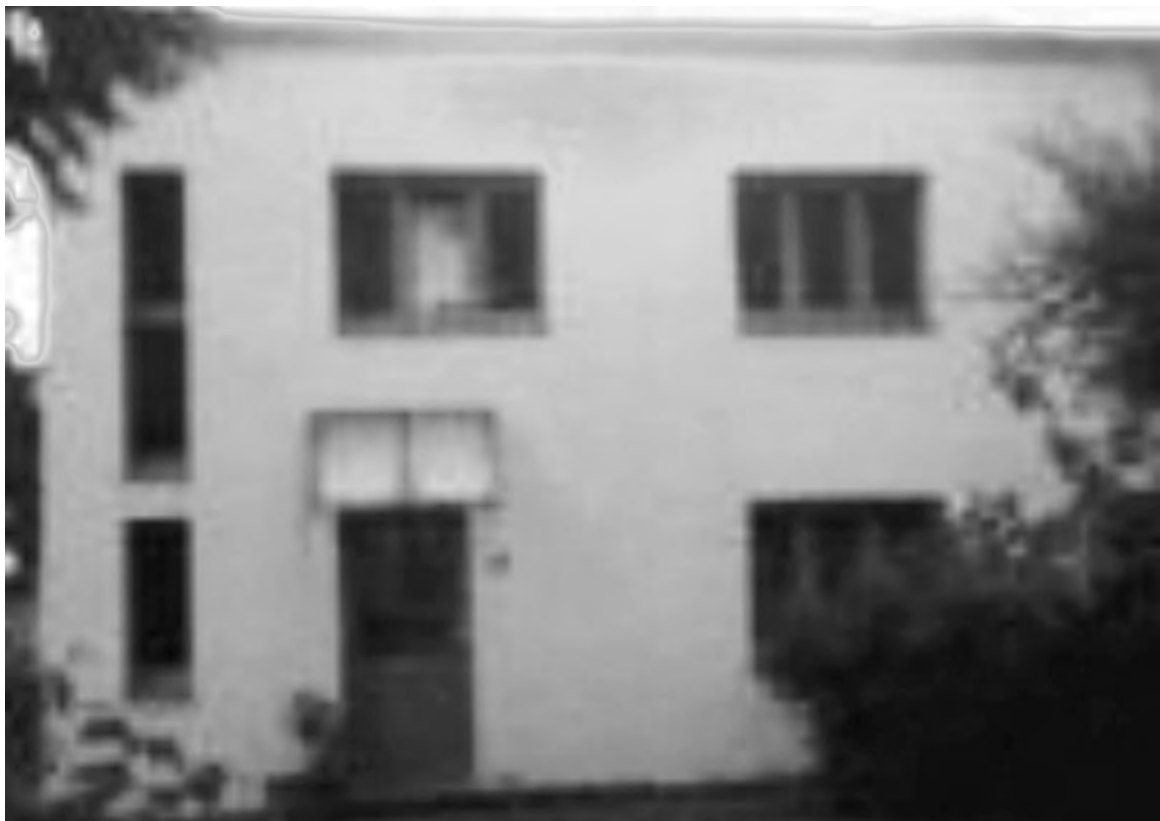
Figure 3-22: Seismic feature (small openings in infill walls): Facade of a low-rise house (Karlsruhe). Photo by Maria Bostenaru, 2004.

the spacing of metal elements used, for example in Celle (where many joists were missing). Images showing details of openings in mid-rise buildings can be seen in fig. 3-17 (long facade of a typical building) and 3-19 (short facade of a typical building bar). The size and the distribution of windows in a typical low-rise building can be seen in figure 3-22.

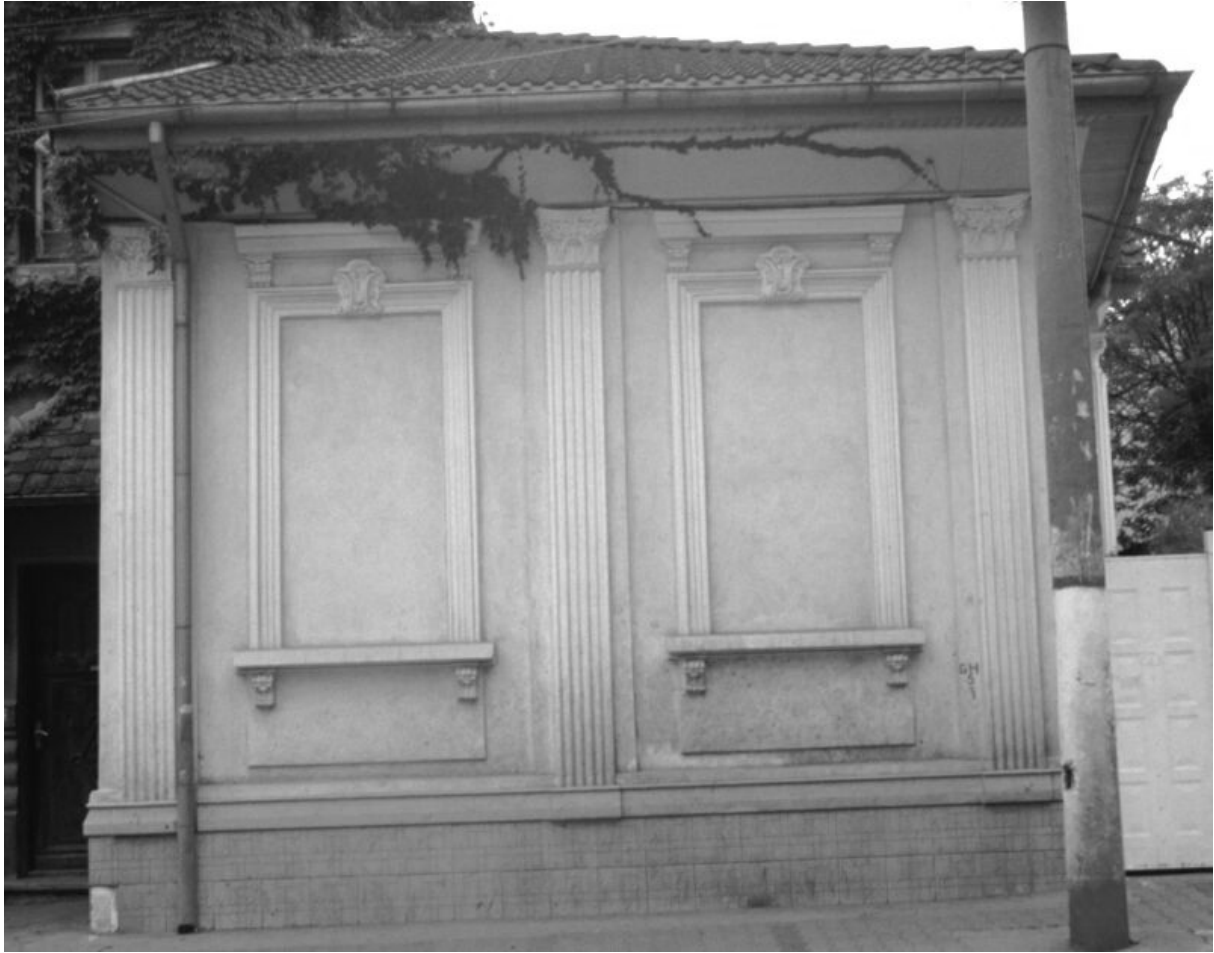
Figure 4-7: Structural modification: Facade with walled-up windows. Photo by Maria Bostenaru, 2002.

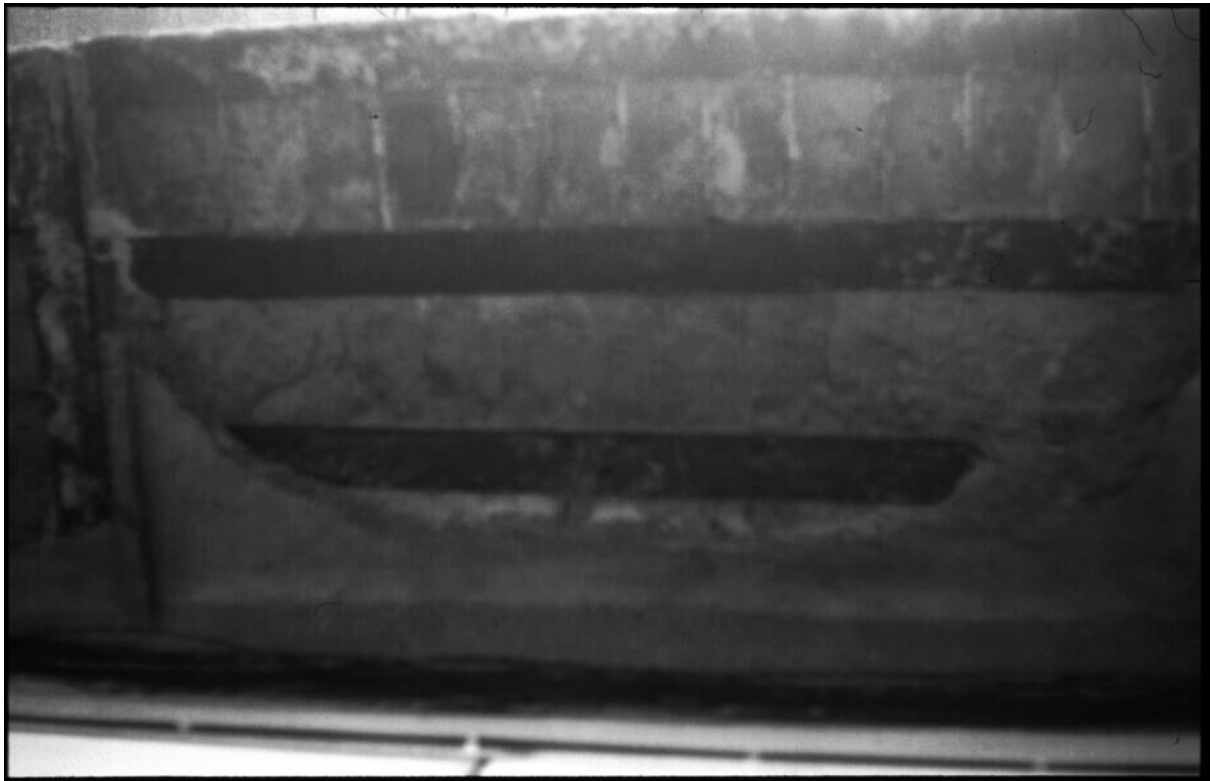
Figure 4-28: Photo of a brick and metal joists floor structure. Photo by Maria Bostenaru, 2002.

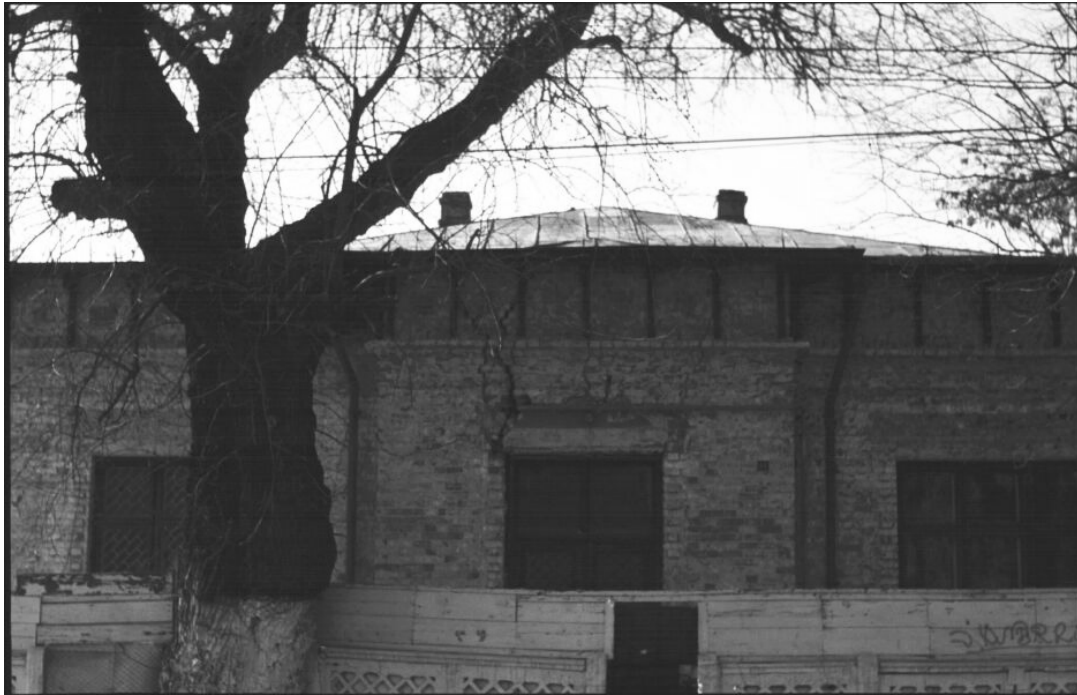
Figure 4-30: Damage over opening (from Bostenaru, 2004, TAFEL VII)

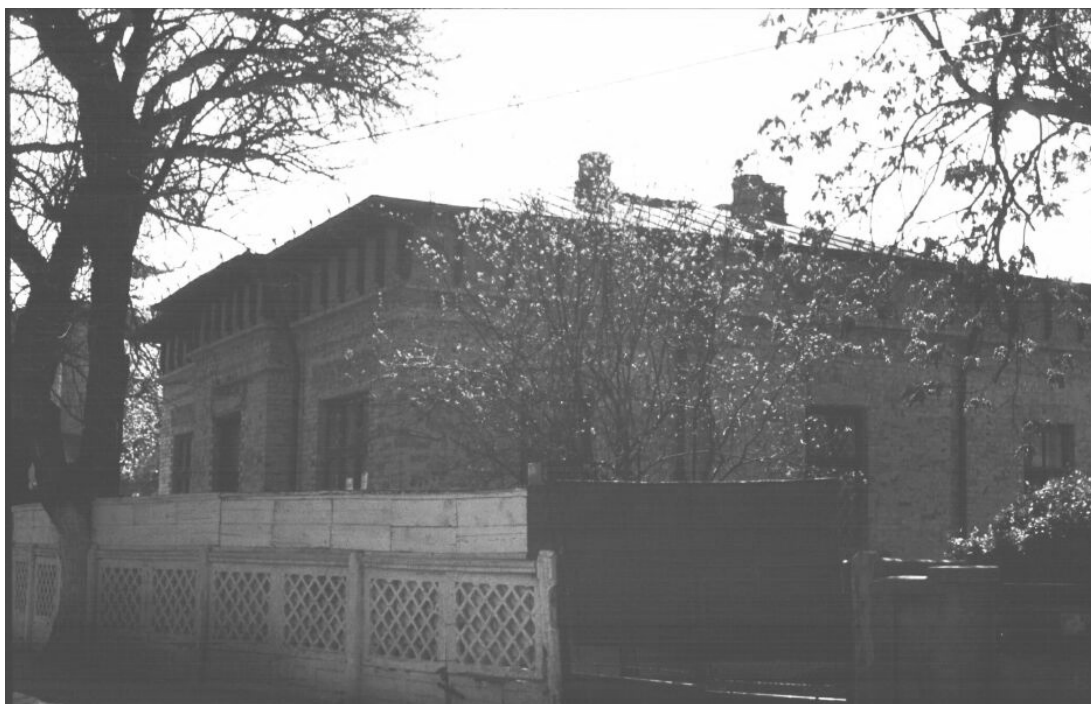
Figure 4-31: Damage at corner. Photo by Maria Bostenaru, 2002.

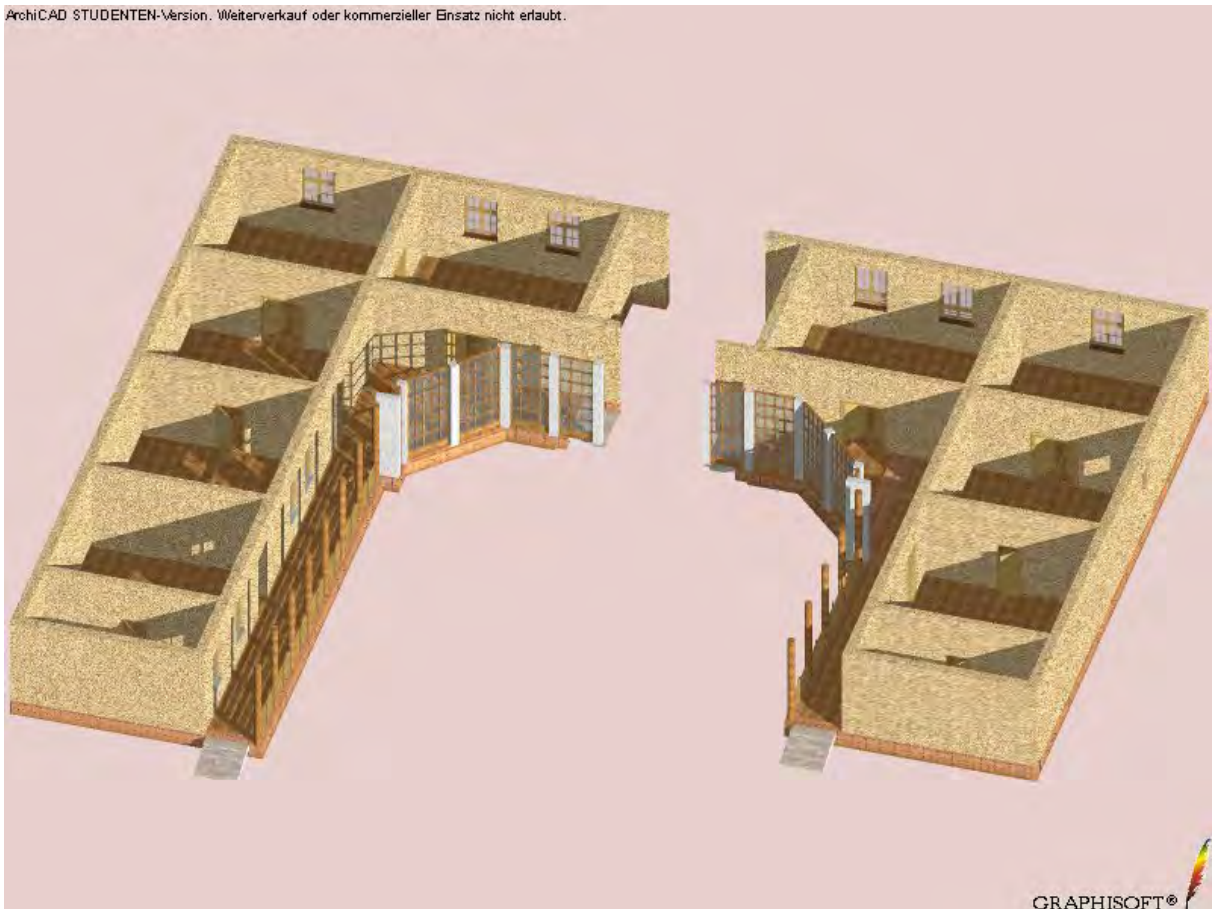
Figure 6-30: Wall structure of coupled buildings

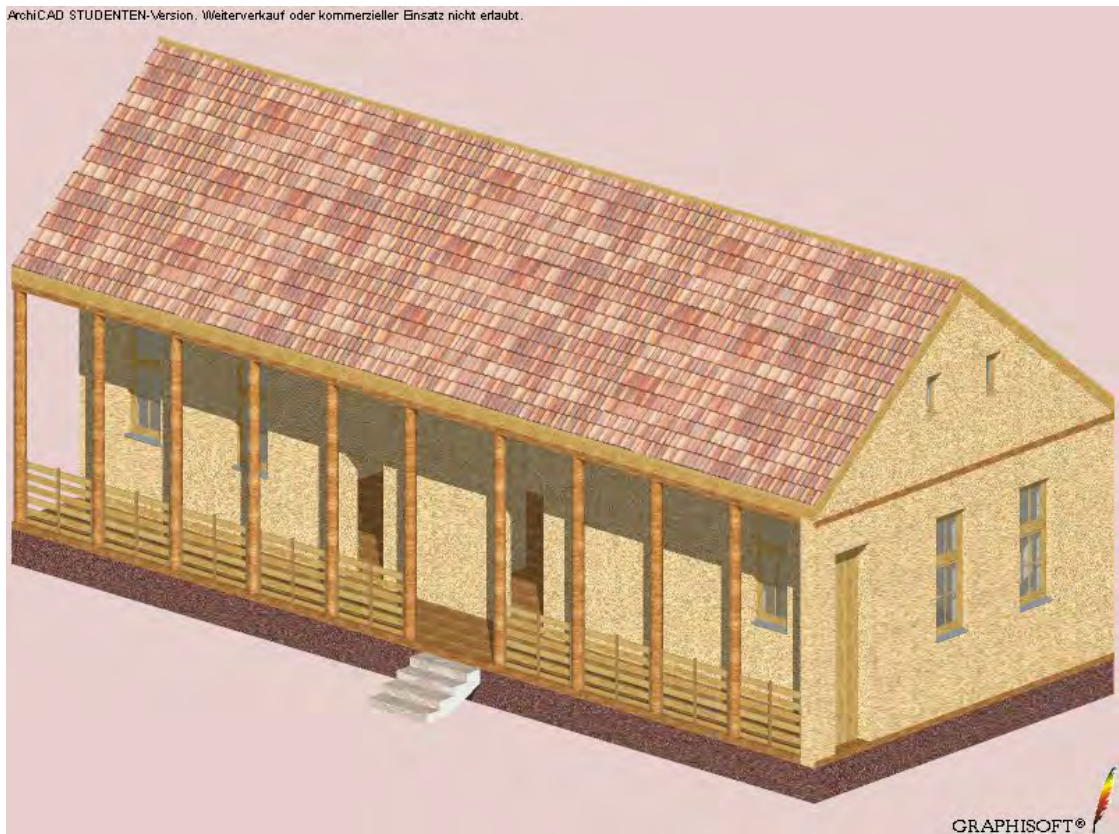
Figure 6-33: Axonometric view of a typical house.
